Grange

ARCHITECTURAL INVENTORYBLOCK No.
ITEM.

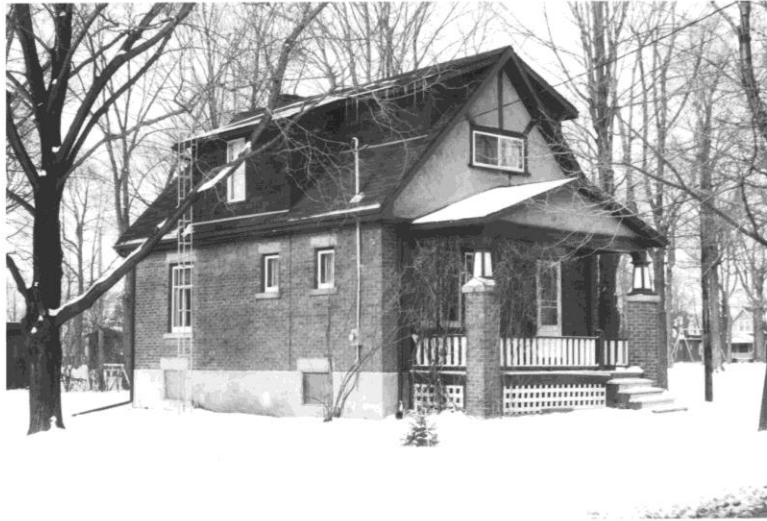
LOCATION 38 GRAUGEARCHITECTCONTRACTORORIGINAL OWNERORIGINAL USE single family dwellingDATE OF CONSTRUCTION 1923-25BUILDING MATERIAL yellow textured brickSIGNIFICANCE none

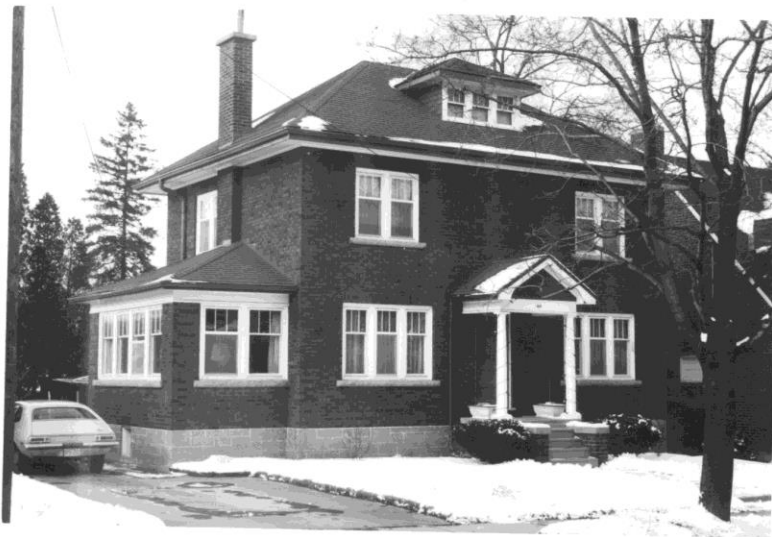
LOCATION 60 GRAUGEARCHITECTCONTRACTORORIGINAL OWNER Alvin R. Burrows (?)ORIGINAL USE single family dwellingDATE OF CONSTRUCTION 1923-25BUILDING MATERIAL brickSIGNIFICANCE none

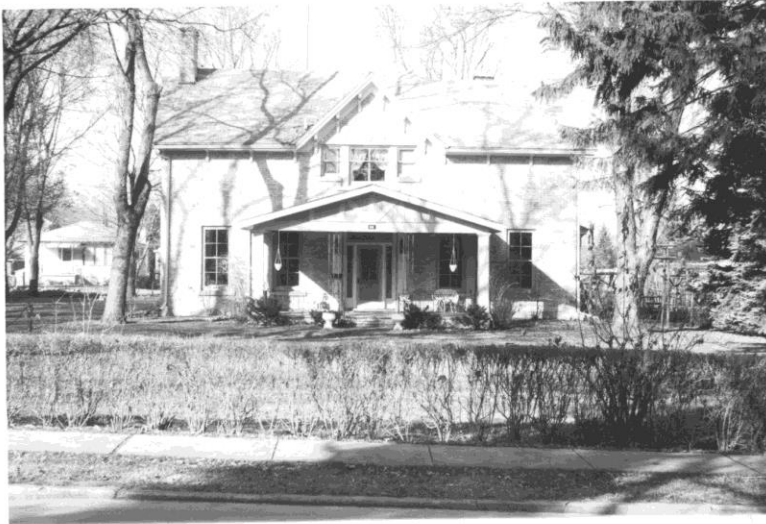
LOCATION 66 GRANGEARCHITECTCONTRACTORORIGINAL OWNERORIGINAL USE single family dwellingDATE OF CONSTRUCTION c.1877-1882 or earlier (later additions)BUILDING MATERIAL yellow brickSIGNIFICANCE Priority #3, character, age

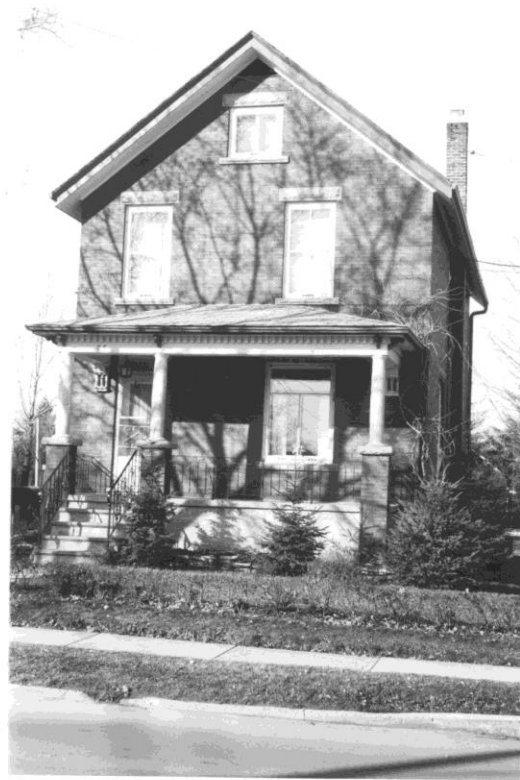
LOCATION 86 GRANGEARCHITECTCONTRACTORORIGINAL OWNER ~~Wm. B. B.~~ORIGINAL USE single family dwellingDATE OF CONSTRUCTION c.1895BUILDING MATERIAL red brickSIGNIFICANCE none

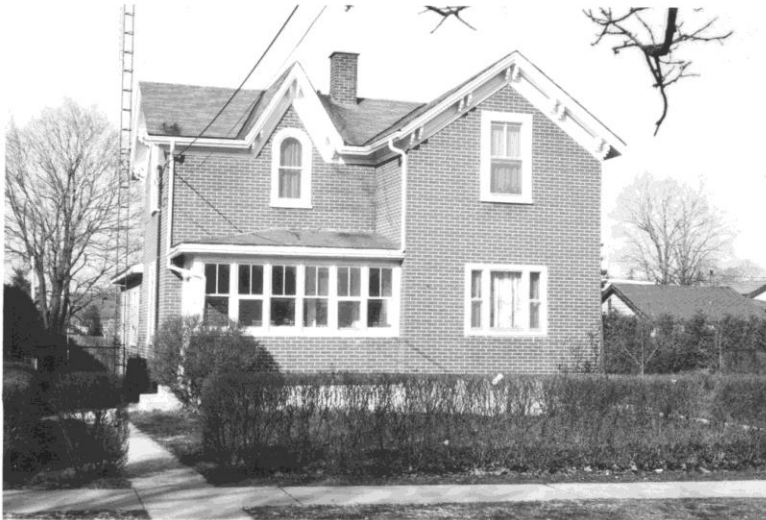
LOCATION 92 GRANGEARCHITECTCONTRACTORORIGINAL OWNERORIGINAL USE single family dwellingDATE OF CONSTRUCTION c.1876-1884BUILDING MATERIAL imitation brick siding over stucco or frame.SIGNIFICANCE none

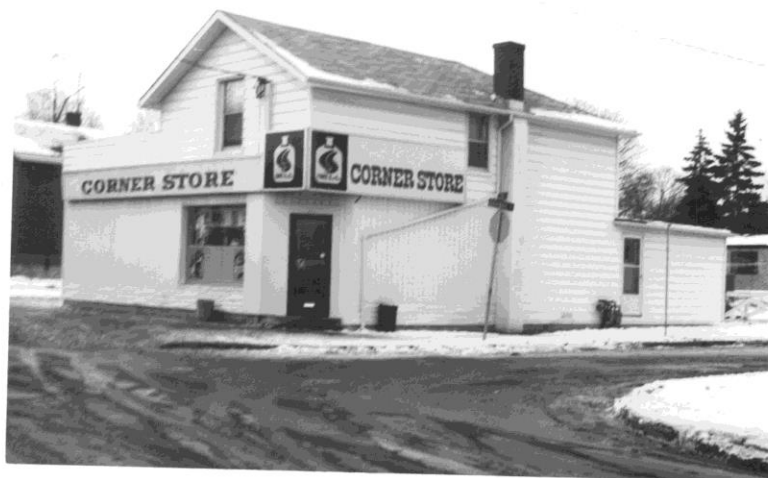
LOCATION 100 GRANGEARCHITECTCONTRACTORORIGINAL OWNER John Jackson (?)ORIGINAL USE single family dwelling (uncertain if store included)DATE OF CONSTRUCTION c.1880BUILDING MATERIAL siding over stucco-frameSIGNIFICANCE none

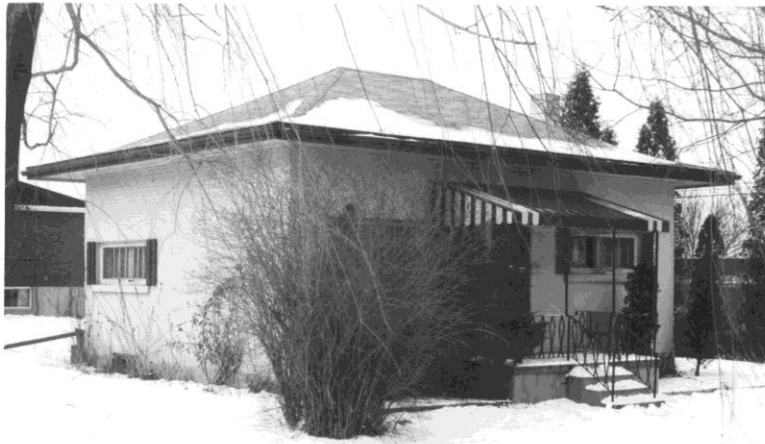
LOCATION 106 GRANGEARCHITECTCONTRACTORORIGINAL OWNERORIGINAL USE single family dwellingDATE OF CONSTRUCTION uncertain: as late as 1914 or as early as 1880.BUILDING MATERIAL painted brick stuccoSIGNIFICANCE priority #5. Unique design, good corner site.

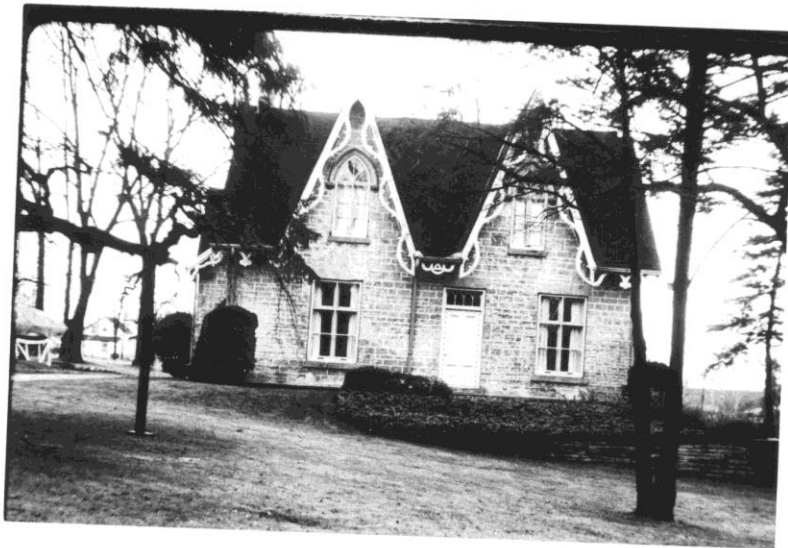
LOCATION 140 GRANGEARCHITECTCONTRACTORORIGINAL OWNER StephensonORIGINAL USE single family dwellingDATE OF CONSTRUCTION early 1850's (before 1860)BUILDING MATERIAL local limestoneSIGNIFICANCE Priority #1. One of city's architectural 'treasures'.
Very unique Gothic Revival style, good condition, fine site.

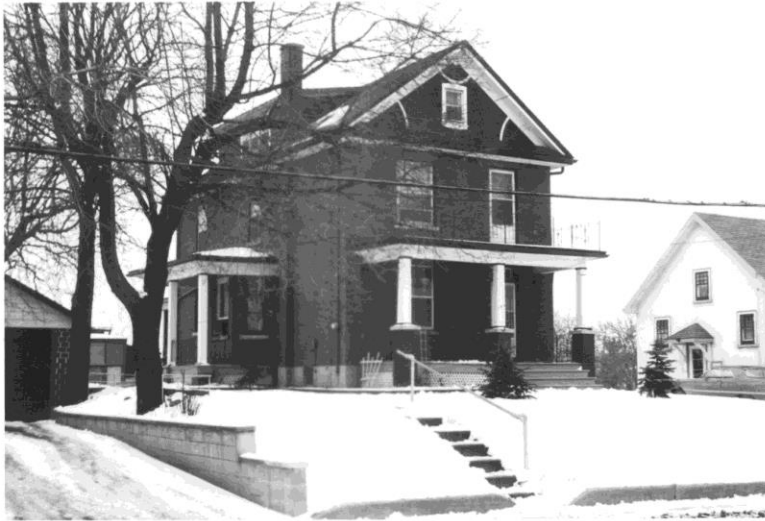
LOCATION 158 GRAUGEARCHITECTCONTRACTORORIGINAL OWNERORIGINAL USE single family dwellingDATE OF CONSTRUCTION c.1900-1895BUILDING MATERIAL red brickSIGNIFICANCE none

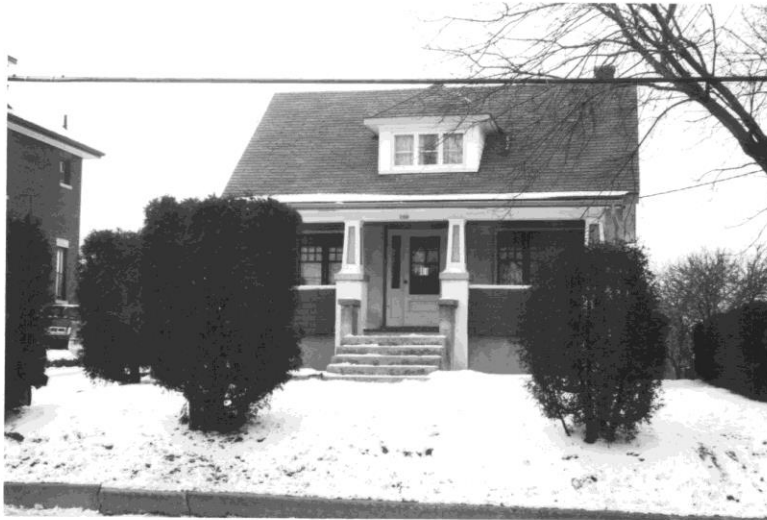
LOCATION 160 GRANGEARCHITECTCONTRACTORORIGINAL OWNERORIGINAL USE single family dwellingDATE OF CONSTRUCTION c.1890'sBUILDING MATERIAL stuccoSIGNIFICANCE none

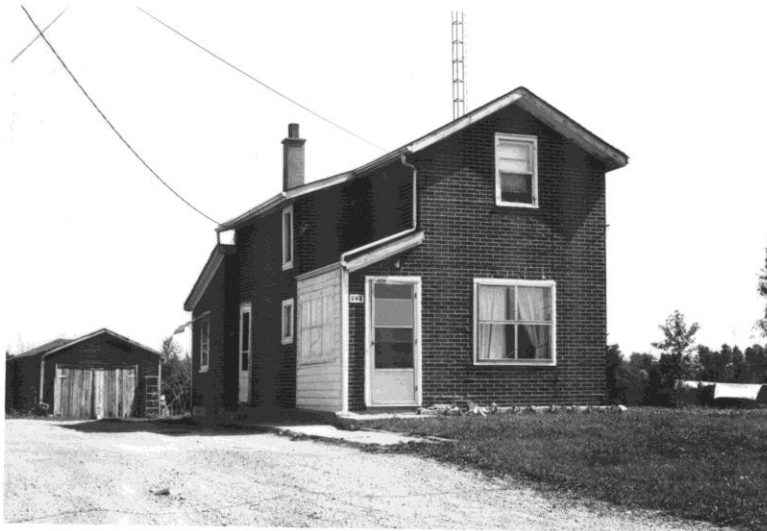
LOCATION 264 Grange RoadARCHITECTCONTRACTORORIGINAL OWNERORIGINAL USE single family dwellingDATE OF CONSTRUCTION uncertain - 1910-20BUILDING MATERIAL 'insul-brick' composition sidingSIGNIFICANCE none

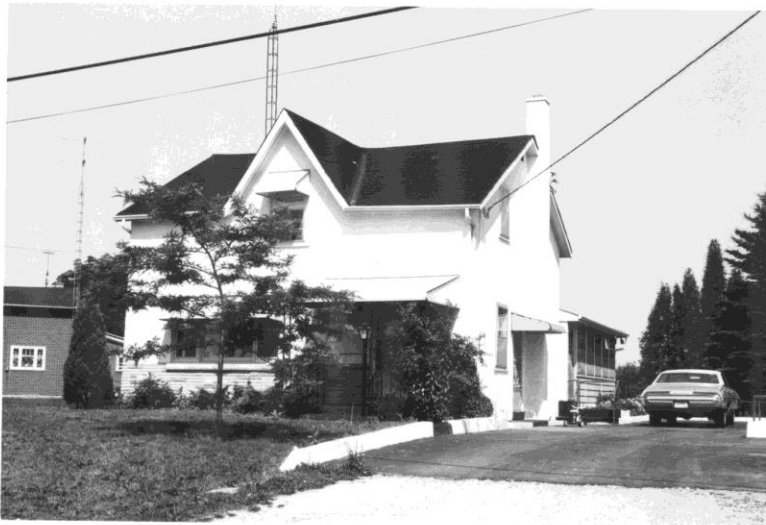
LOCATION 270 Grange RoadARCHITECTCONTRACTORORIGINAL OWNERORIGINAL USE single family dwellingDATE OF CONSTRUCTION 1885-1895 (plus later alterations)BUILDING MATERIAL stucco on brickSIGNIFICANCE none

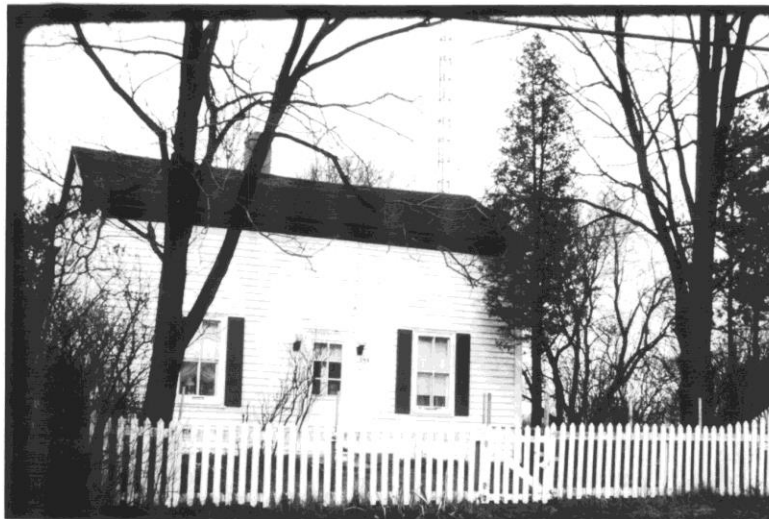
LOCATION 284 GRANGE STREETARCHITECTCONTRACTORORIGINAL OWNERORIGINAL USE single family dwellingDATE OF CONSTRUCTION 1870'sBUILDING MATERIAL clapboarded frame sidingSIGNIFICANCE limited.

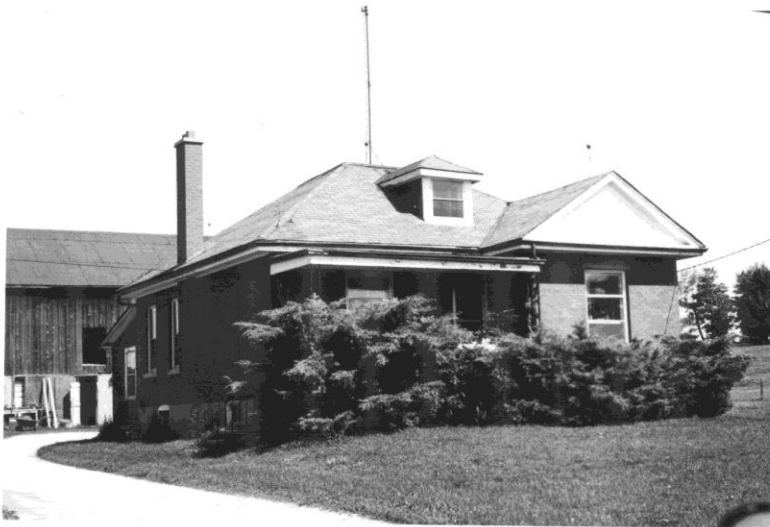
LOCATION Grange Road, north side, between 284,336ARCHITECTCONTRACTORORIGINAL OWNERORIGINAL USE single family dwellingDATE OF CONSTRUCTION 1910-1920BUILDING MATERIAL red brick with stone lintels and sillsSIGNIFICANCE none

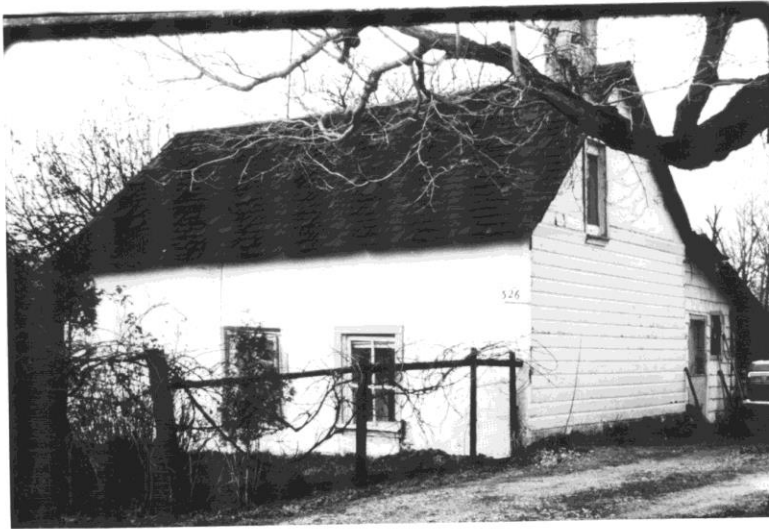
LOCATION 326 GRANGE STREETARCHITECTCONTRACTORORIGINAL OWNERORIGINAL USE single family dwellingDATE OF CONSTRUCTION 1840'sBUILDING MATERIAL clapboard siding and stucco over logs.SIGNIFICANCE Priority #2. One of the very few surviving log houses.
Could be restored.

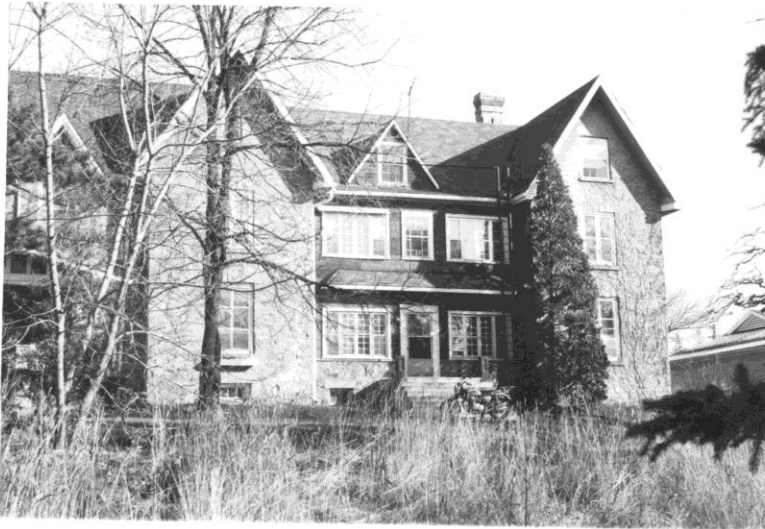
ARCHITECTURAL INVENTORYBLOCK No. PAGE
ITEM.LOCATION31
~~79~~
A
GRANGE

1854-55 (Addition 1875)

local limestone

Priority #1. One of the early stone mansions. Could be improved in appearance with sympathetic restoration.
Home of several historic city families.

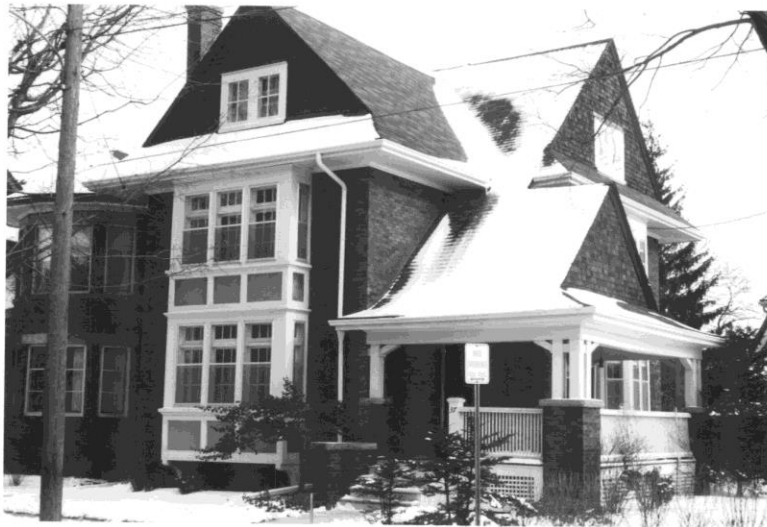
LOCATION 37 GRAUGEARCHITECTCONTRACTORORIGINAL OWNER Charles Yates (?)ORIGINAL USE single family dwellingDATE OF CONSTRUCTION ~~1910~~ c.1914
xxxBUILDING MATERIAL brickSIGNIFICANCE limited

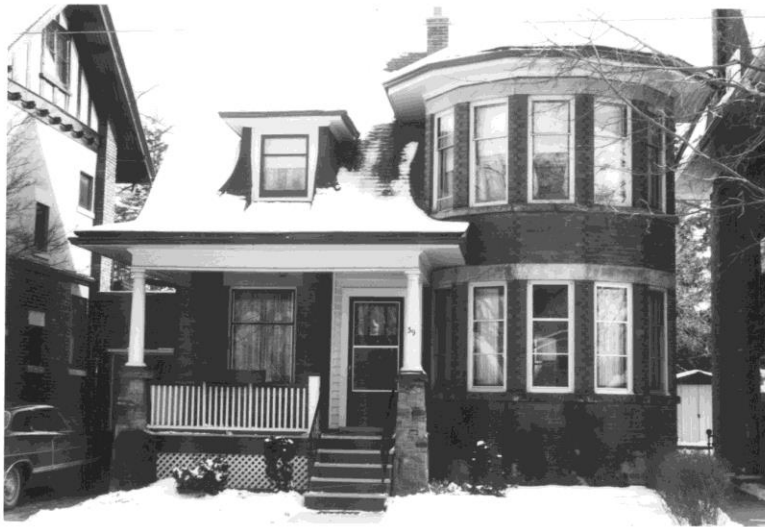
LOCATION 39 GRANGEARCHITECTCONTRACTORORIGINAL OWNERORIGINAL USE single family dwellingDATE OF CONSTRUCTION 1910-1914BUILDING MATERIAL brickSIGNIFICANCE limited

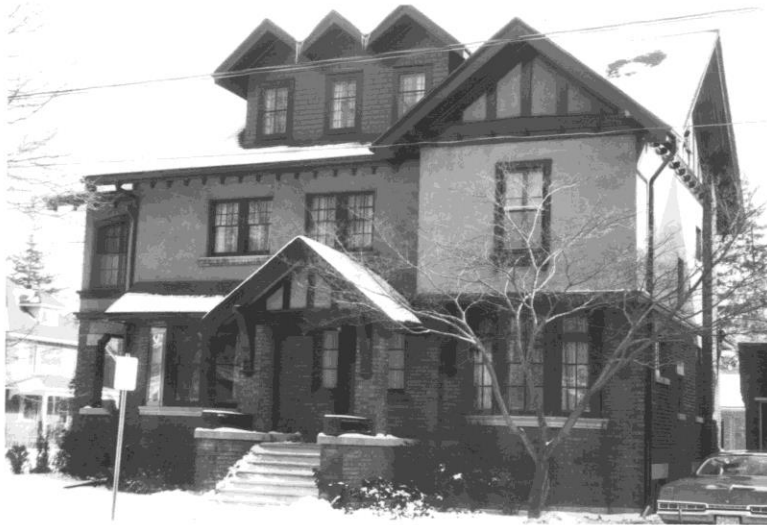
LOCATION 41 GRAUGEARCHITECTCONTRACTORORIGINAL OWNER F. E. Partridge (?)ORIGINAL USE single family dwellingDATE OF CONSTRUCTION 1910-14BUILDING MATERIAL brick first floor, stucco, second floorSIGNIFICANCE limited to grouping

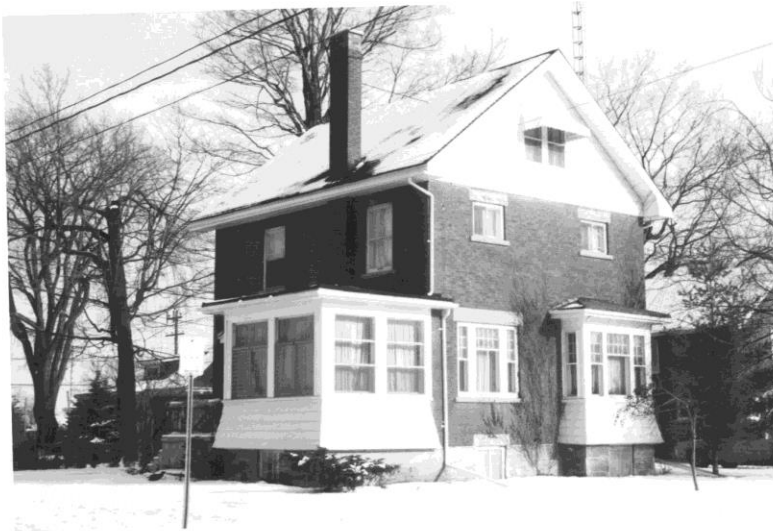
LOCATION 47 GRANGEARCHITECTCONTRACTORORIGINAL OWNERORIGINAL USE single family dwellingDATE OF CONSTRUCTION c.1900BUILDING MATERIAL red brickSIGNIFICANCE none

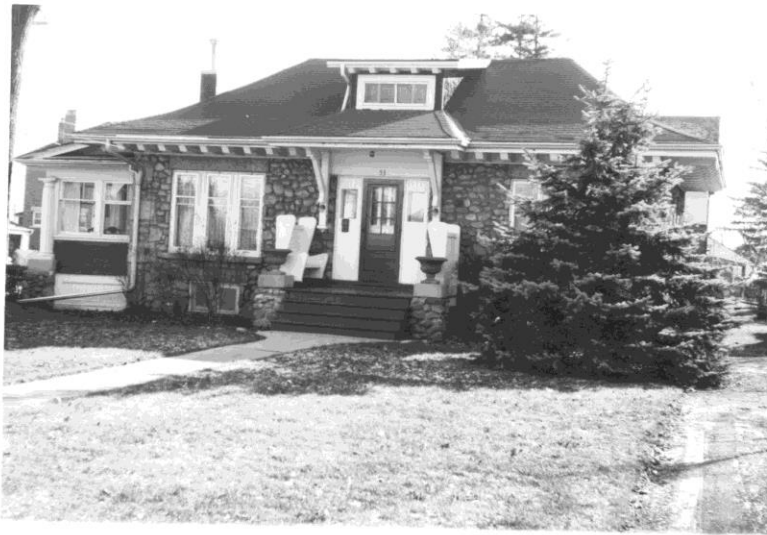
LOCATION 53 GRANGEARCHITECTCONTRACTORORIGINAL OWNERORIGINAL USE single family dwellingDATE OF CONSTRUCTION c.1900-1910 *Appears to have been in existence
in 1877*BUILDING MATERIAL cobblestoneSIGNIFICANCE Priority #2, Unique, well sited, material.

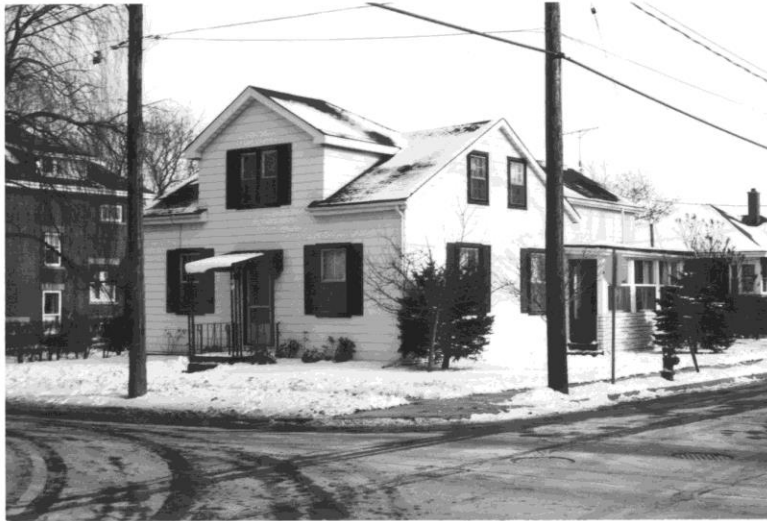
LOCATION 57 GRANGEARCHITECTCONTRACTORORIGINAL OWNERORIGINAL USE single family dwellingDATE OF CONSTRUCTION c.1875-1880BUILDING MATERIAL siding over (frame-stucco?)SIGNIFICANCE none

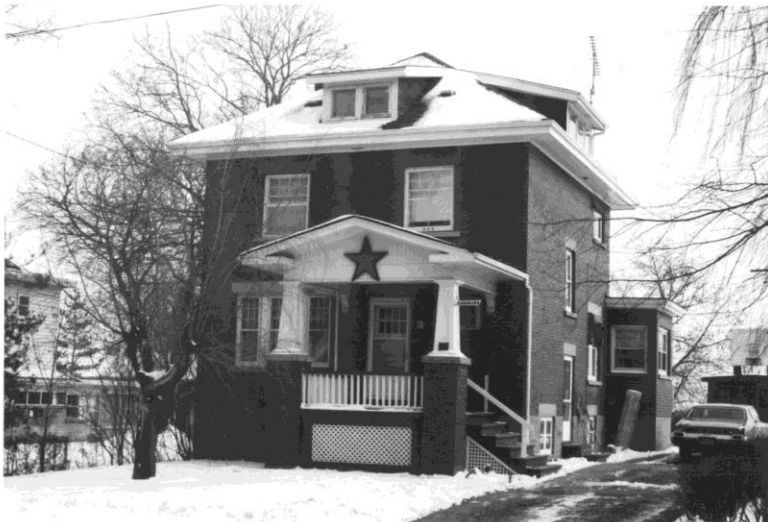
LOCATION 61 GRANGEARCHITECTCONTRACTORORIGINAL OWNER M.J. Barry(?)ORIGINAL USE single family dwellingDATE OF CONSTRUCTION c.1914BUILDING MATERIAL brickSIGNIFICANCE none

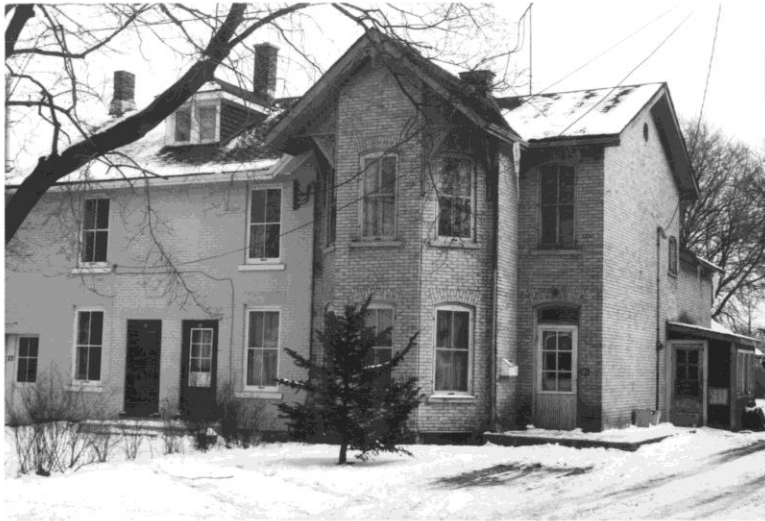
LOCATION 71-73-75-~~77~~ GRANGEARCHITECTCONTRACTORORIGINAL OWNERORIGINAL USE west half of three unit dwelling terrace,
#75-75 may be later in filling.DATE OF CONSTRUCTION c.1885 #73-75 may be later in-filling
various alterations and additionsBUILDING MATERIAL west unit: yellow brickSIGNIFICANCE none

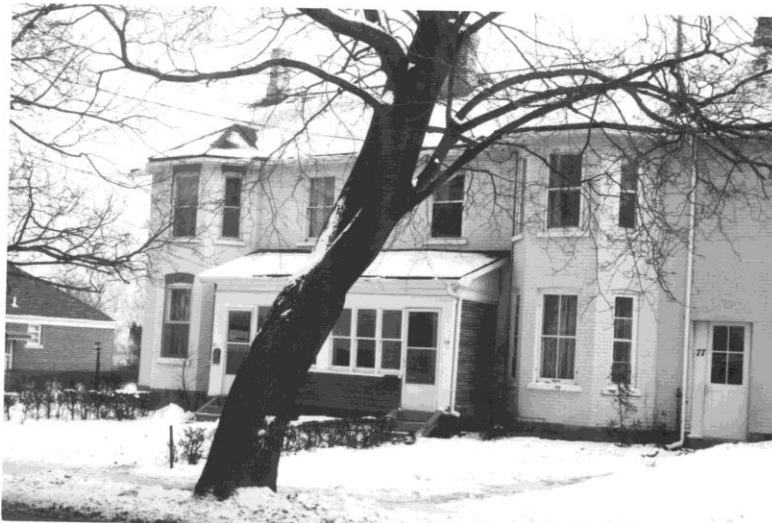
LOCATION 77-79-81 GRANGEARCHITECTCONTRACTORORIGINAL OWNERORIGINAL USE two~~u~~ unit dwelling (#79-81) (#77 appears later)DATE OF CONSTRUCTION c.1880'sBUILDING MATERIAL brick (yellow?) paintedSIGNIFICANCE none

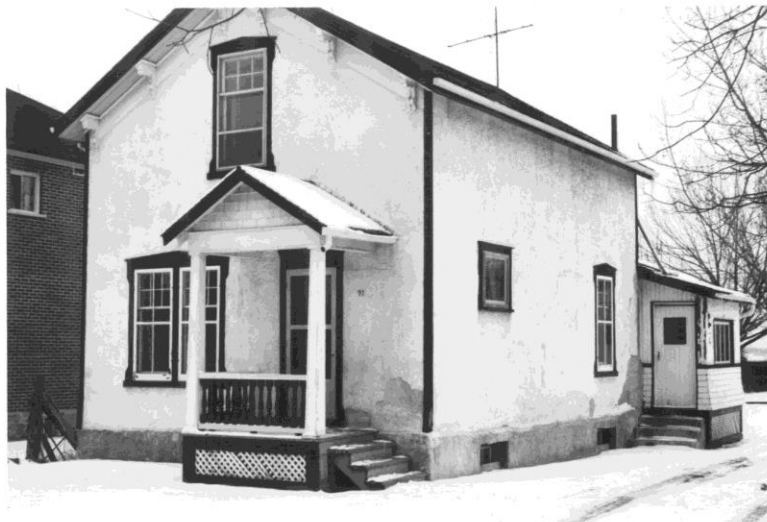
LOCATION 91 GRANGE

DATE OF CONSTRUCTION ~~1870's~~ 1870's 1876-1882

BUILDING MATERIAL stucco

SIGNIFICANCE none

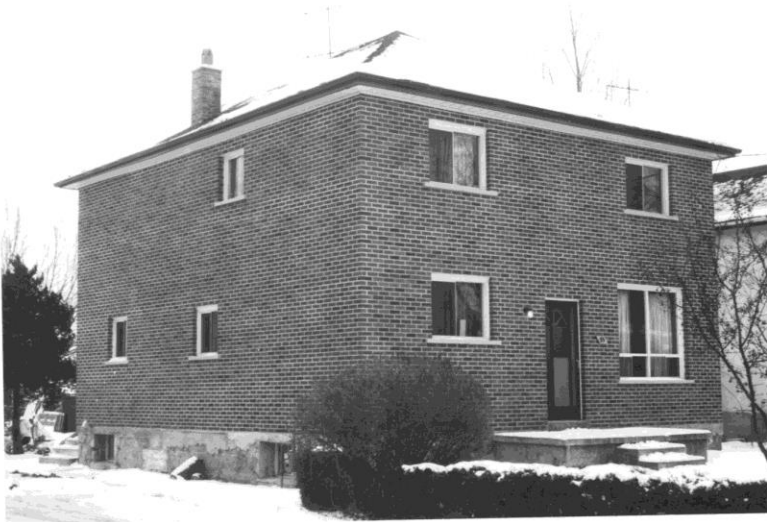
LOCATION 93 GRANGEARCHITECTCONTRACTORORIGINAL OWNERORIGINAL USE single family dwellingDATE OF CONSTRUCTION recently rebuilt (original may have been c.1914)BUILDING MATERIAL brick veneerSIGNIFICANCE none

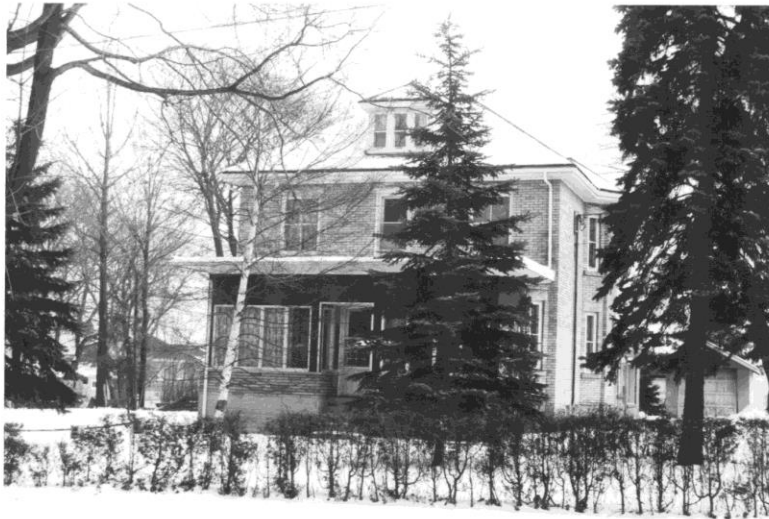
LOCATION 95 GRANGEARCHITECTCONTRACTORORIGINAL OWNER F. Yates(?)ORIGINAL USE single family dwellingDATE OF CONSTRUCTION 1914-25BUILDING MATERIAL yellow brickSIGNIFICANCE none

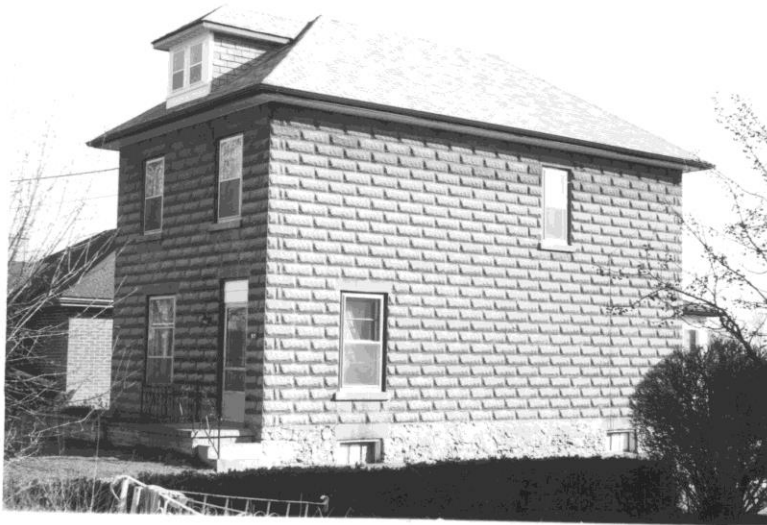
LOCATION 97 GRANBE

DATE OF CONSTRUCTION c.1900-1910

BUILDING MATERIAL concrete block - early version

SIGNIFICANCE none

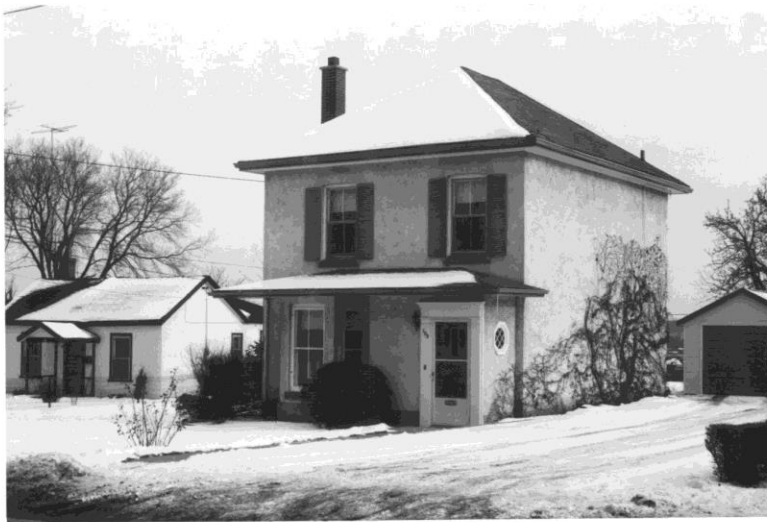
LOCATION 105 GRANGEARCHITECTCONTRACTORORIGINAL OWNERORIGINAL USE single family dwellingDATE OF CONSTRUCTION c.1890-96BUILDING MATERIAL stucco (over brick?)SIGNIFICANCE none

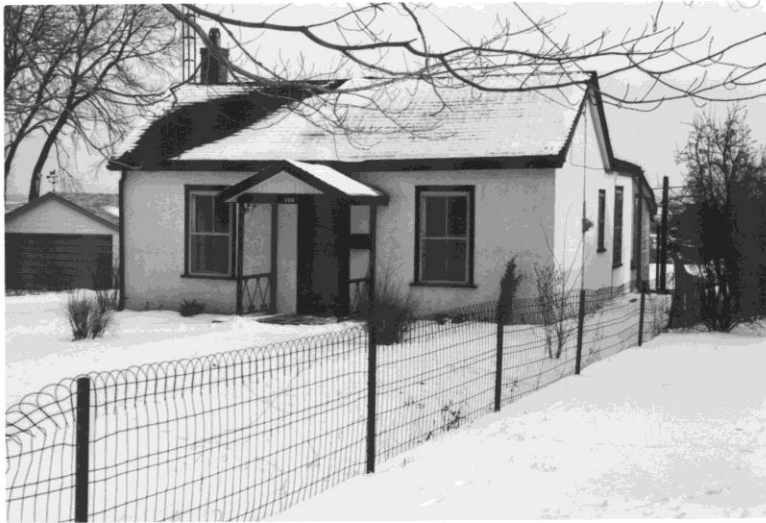
LOCATION 109 GRANGEARCHITECTCONTRACTORORIGINAL OWNERORIGINAL USE single family dwellingDATE OF CONSTRUCTION c.1880 or earlierBUILDING MATERIAL stuccoSIGNIFICANCE Priority #5. age, type, style

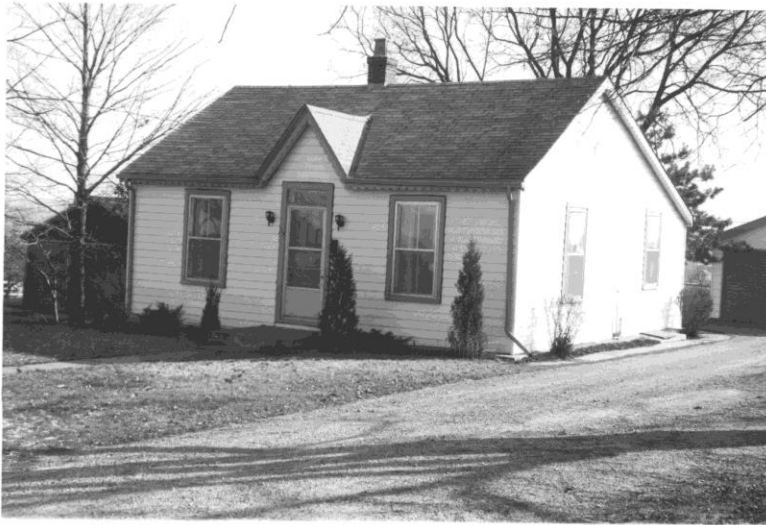
LOCATION 113 GRANGEARCHITECTCONTRACTORORIGINAL OWNERORIGINAL USE single family dwellingDATE OF CONSTRUCTION c.1880BUILDING MATERIAL frame clapboard sidingSIGNIFICANCE Priority #5. Few remaining frame clapboarded houses.
fair condition.

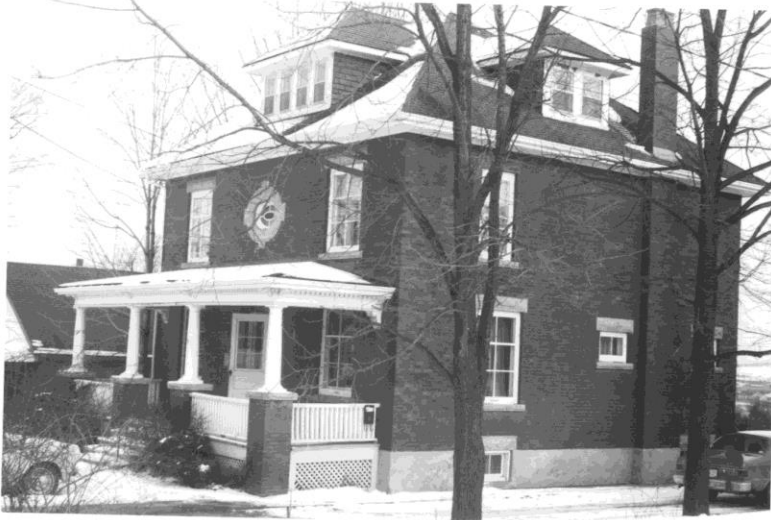
ARCHITECTURAL INVENTORYBLOCK No. PAGE
ITEM.LOCATION 117 GRANGEARCHITECTCONTRACTORORIGINAL OWNERORIGINAL USE single family dwellingDATE OF CONSTRUCTION c.1895-1905BUILDING MATERIAL red brick with stone trimSIGNIFICANCE limited

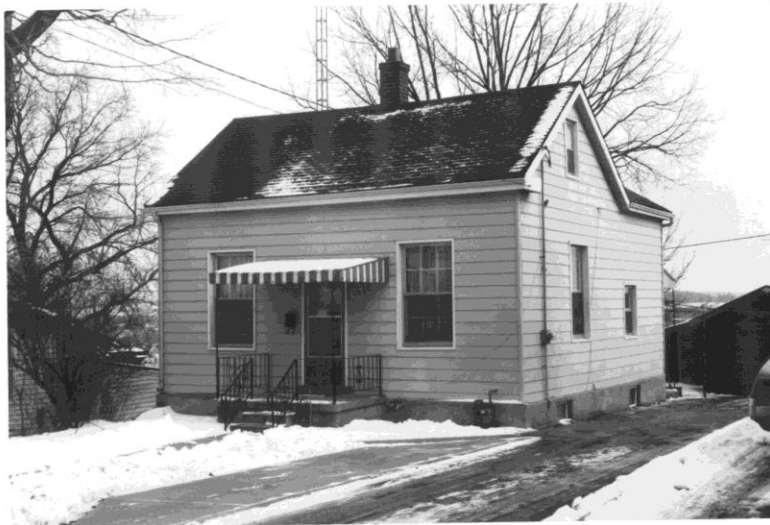
LOCATION 121 GRANGEARCHITECTCONTRACTORORIGINAL OWNERORIGINAL USE single family dwellingDATE OF CONSTRUCTION c.1880BUILDING MATERIAL clapboard siding over (stucco-frame)SIGNIFICANCE none

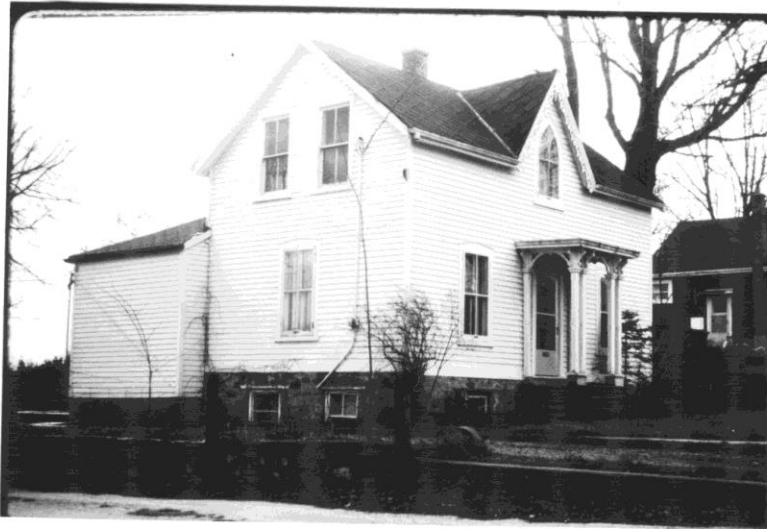
LOCATION 123 GRAUGEARCHITECTCONTRACTORORIGINAL OWNERORIGINAL USE single family dwellingDATE OF CONSTRUCTION 1880's or earlier, possibly 1870'sBUILDING MATERIAL frame clapboard sidingSIGNIFICANCE *riority #4. Few frame clapboard houses survive in the city. This is a good example, good condition.

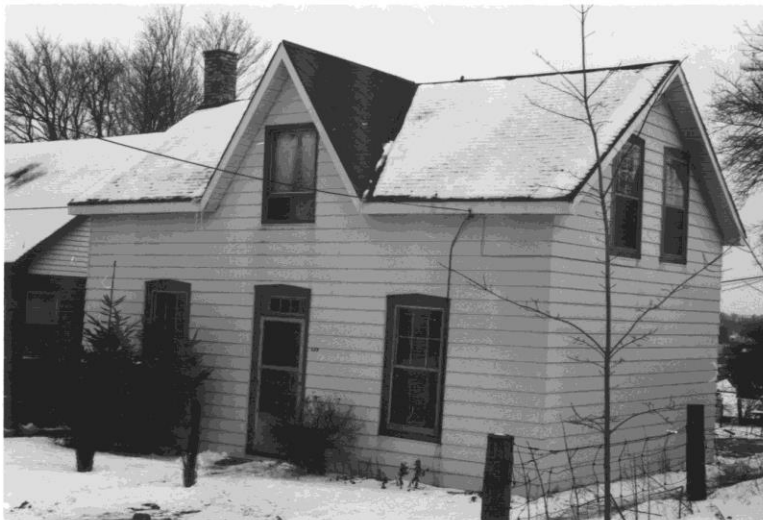
LOCATION 125 GRANGEARCHITECTCONTRACTORORIGINAL OWNERORIGINAL USE single family dwellingDATE OF CONSTRUCTION c.1875-85BUILDING MATERIAL new clapboard siding over (stucco-frame?)SIGNIFICANCE Priority #5. A group of modest sided houses.

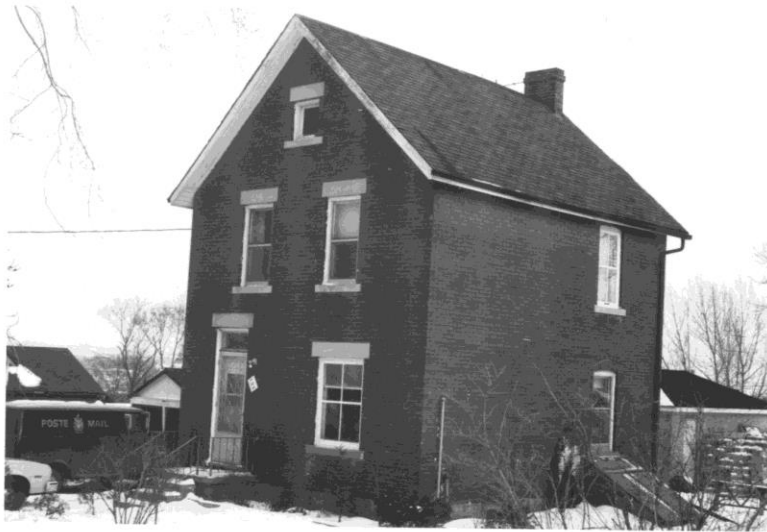
LOCATION 131 GRANGEARCHITECTCONTRACTORORIGINAL OWNERORIGINAL USE single family dwellingDATE OF CONSTRUCTION c.1900-1910BUILDING MATERIAL red brickSIGNIFICANCE none

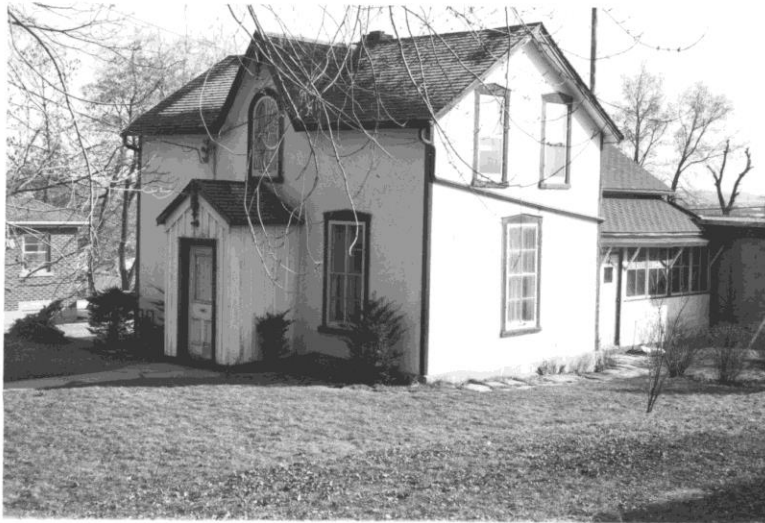
LOCATION 1735 GRANGEARCHITECTCONTRACTORORIGINAL OWNERORIGINAL USE single family dwellingDATE OF CONSTRUCTION c.1875BUILDING MATERIAL stucco, with board and batten porchSIGNIFICANCE Priority #4. Good example of type, Fine porch.

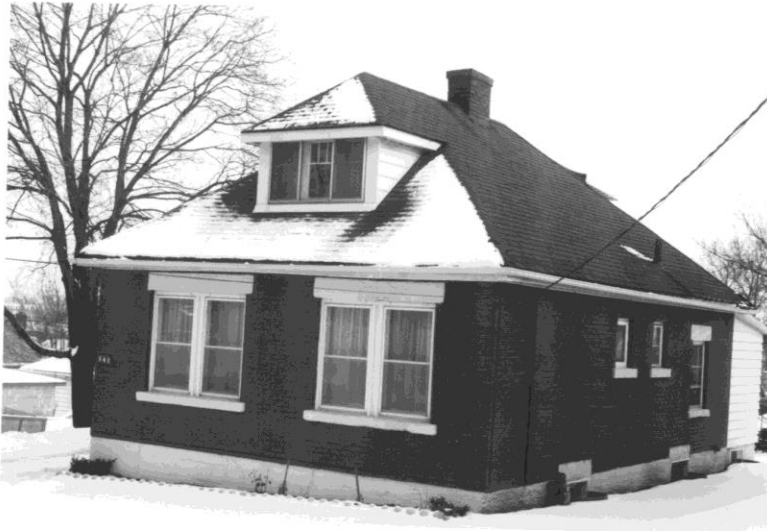
LOCATION 141 GRAVEARCHITECTCONTRACTORORIGINAL OWNERORIGINAL USE single family dwellingDATE OF CONSTRUCTION c.1918-22BUILDING MATERIAL brickSIGNIFICANCE none

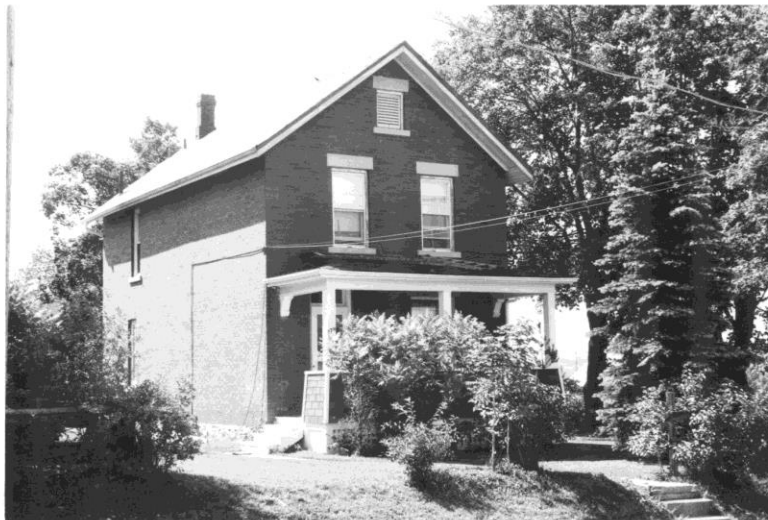
LOCATION 179 GRANGEARCHITECTCONTRACTORORIGINAL OWNER JOHN T. LOWEORIGINAL USE single family dwellingDATE OF CONSTRUCTION 1926-1927 or earlierBUILDING MATERIAL red brickSIGNIFICANCE none

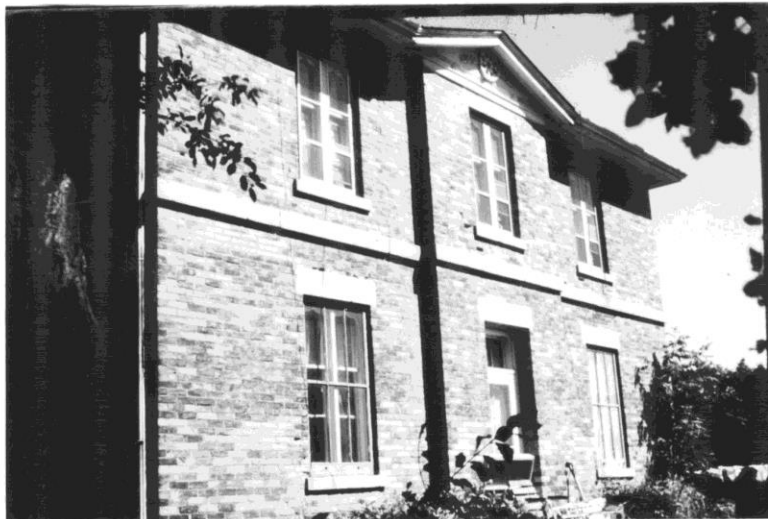
LOCATION 271 GRANGE RDARCHITECTCONTRACTORORIGINAL OWNERORIGINAL USE single family dwellingDATE OF CONSTRUCTION uncertain: probably about 1850BUILDING MATERIAL early local brick with dressed stone belt course.SIGNIFICANCE Priority #2. One of the earlyier brick houses, originally a farm house. Distinctive styling, unique character.
